## 4 Vinci Ringway Capital Scheme Proposals

### 4.1 Duver Road, St Helens

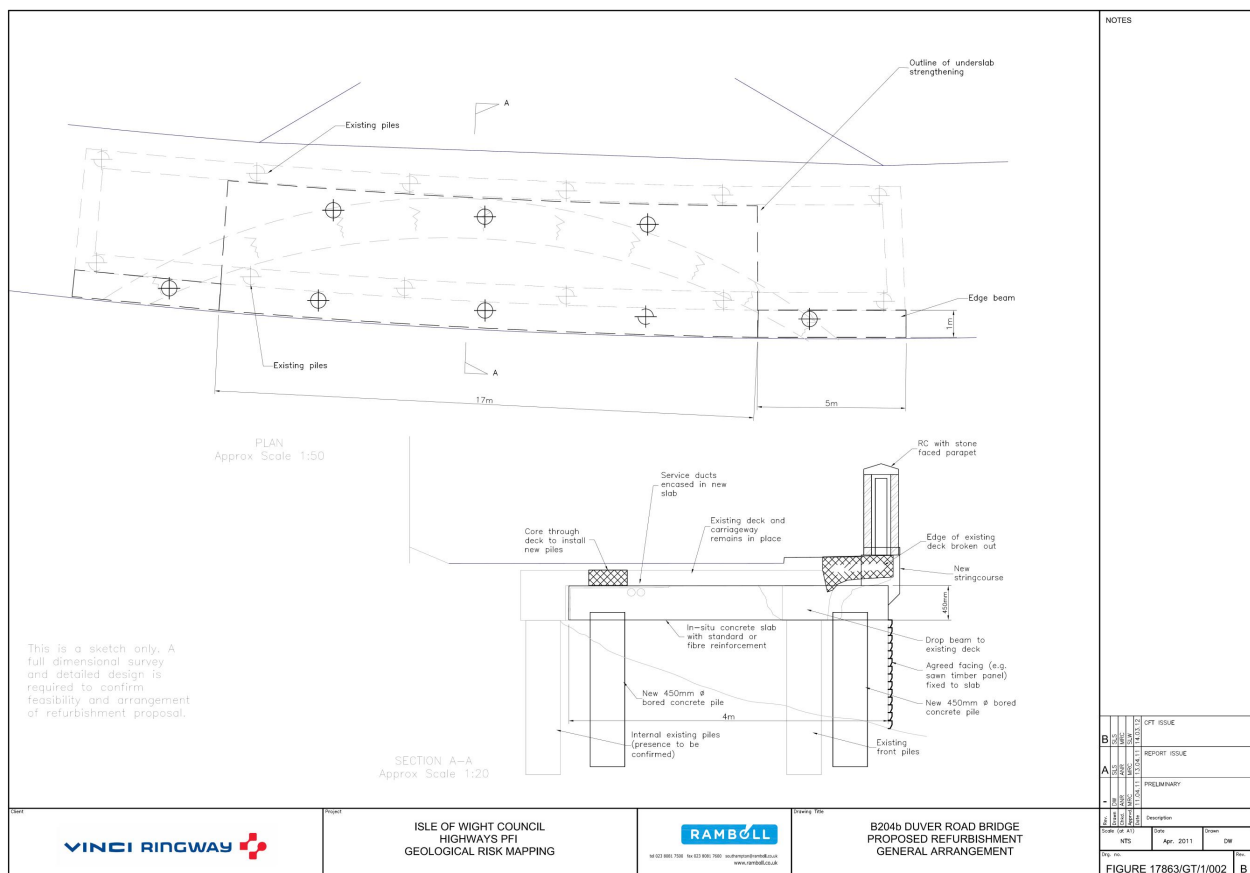
**Figure 4.1: Proposed engineering solution at Duver road**

- 4.1.1 Sub-standard bridge deck and edge restraint with some loss of ground by washout, which is exposing the pile support.

- 4.1.2 **Figure 4.1** illustrates Vinci Ringway's proposed solution, an A3 version of which can be found in **Appendix V**. The solution can be summarised as follows:

- ▶ Complete structural replacement with new piles supporting a new slab;
- ▶ Improved edge capacity, edge restraint;
- ▶ Cosmetic facing to the remaining void beneath the deck; and
- ▶ Short section of sheet piling to low embankment to the west.

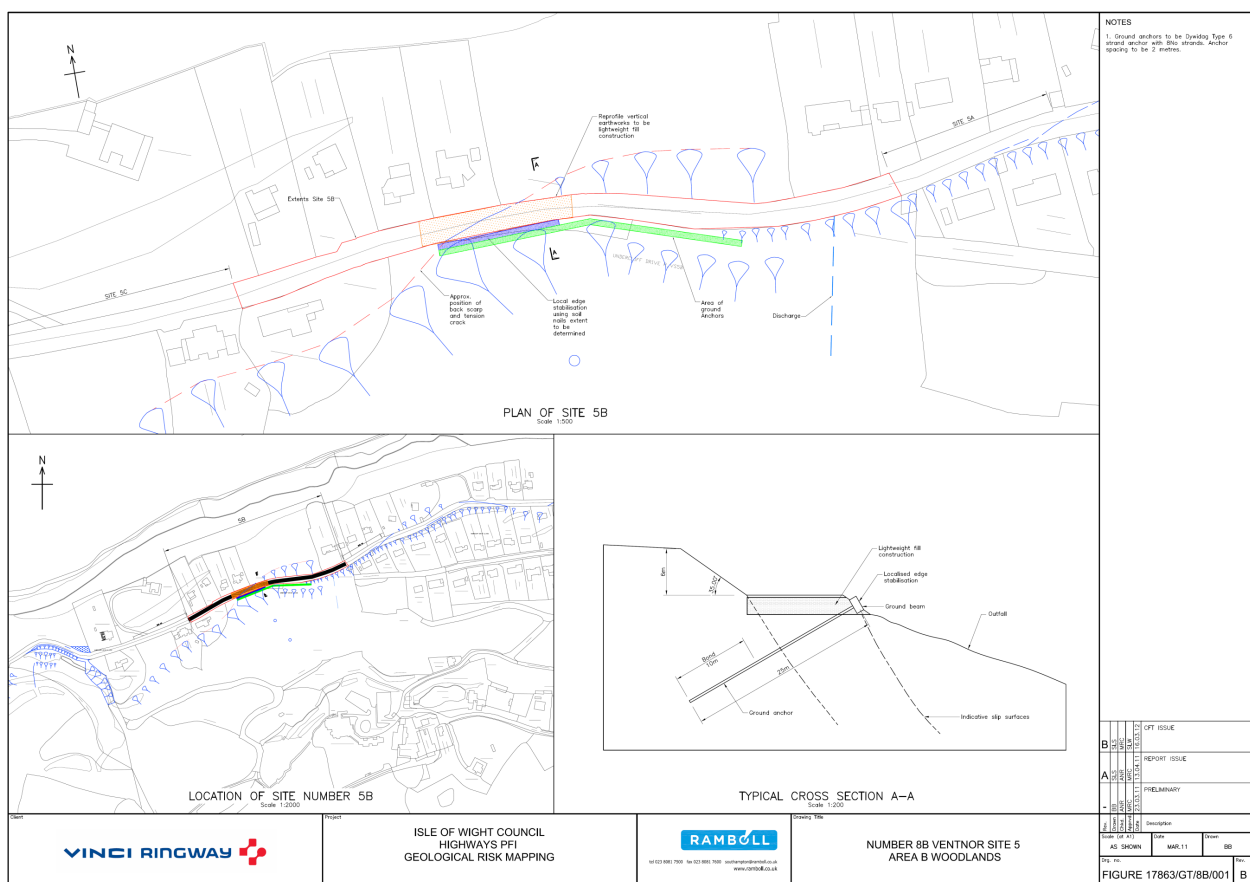
Figure 4.2: Proposed engineering solution at Undercliff Drive Area B

- 4.2.1 Tension cracking and differential settlement of the road surface caused by creep movement of the existing landslide complex. Rotational slip failures occurring on the road surface instigated by rainfall events. Multiple surface repairs are evident and repaired slip movements have led to unsafe steep changes in gradient over short lengths.

- ▶ Ground anchors at scarp edge;
- ▶ Soil nails with flexible facing system on lower south scarp slope; and
- ▶ Adjust road vertical alignment with no net increase in load.

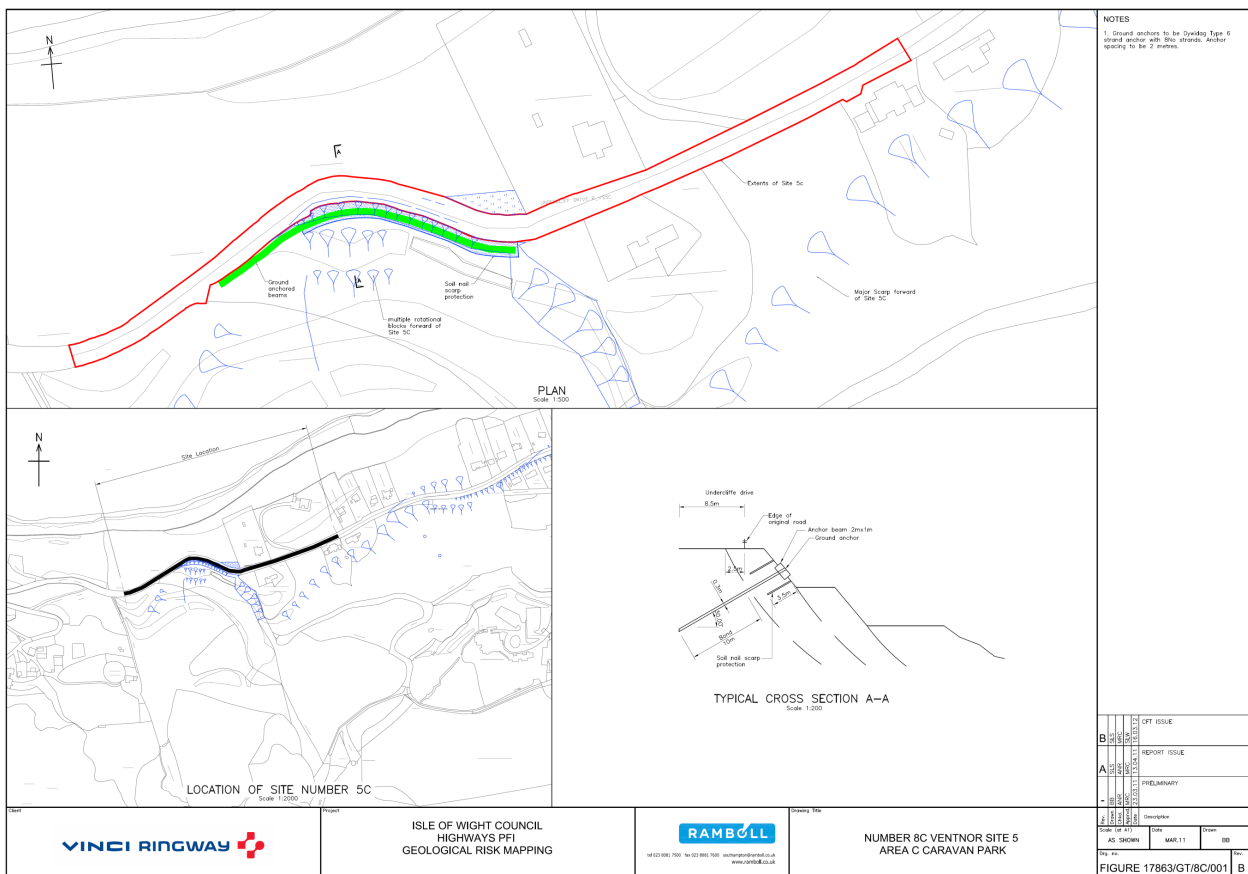
Figure 4.3: Proposed engineering solution at Undercliff Drive Area C

- 4.3.1 Tension crack along length of westbound carriageway caused by creep movement of the existing landslide complex. The tension crack is adjacent to a scarp slope on the seaward/downslope side of the road. Adjacent land also shows signs of localised depression and differential movement.

- ▶ Ground anchors on seaward scarp slope in front of westbound carriageway tension crack;
- ▶ Soil nails with flexible facing system on local scarp slope in association with ground anchors; and
- ▶ New pavement in area damaged by cracking.

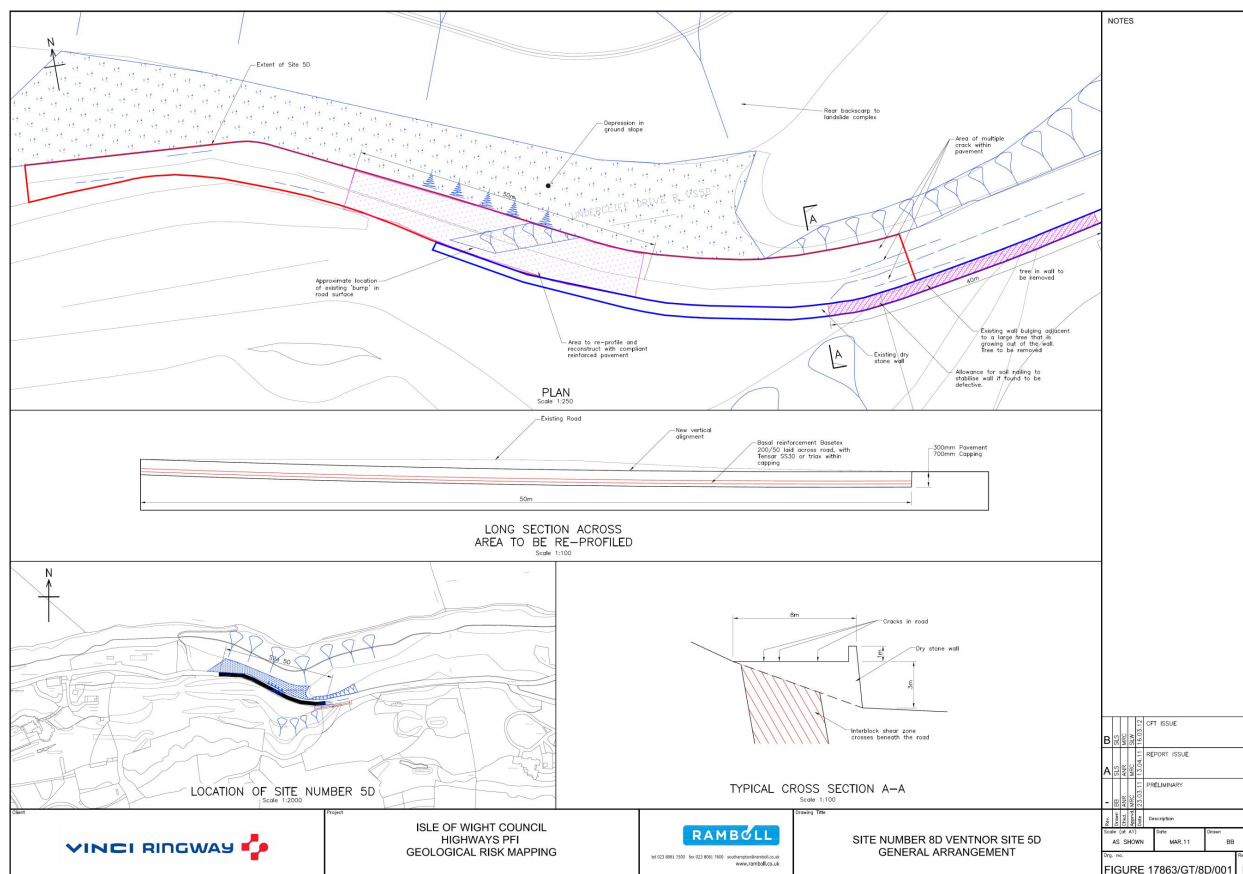
Figure 4.4: Proposed engineering solution at Undercliff Drive Area D

- 4.4.1 Multiple cracks in the road and a differential “bump”. The southern side of the road is supported by a dry stone wall and there are localised bulges in the dry stone wall associated with cracks in the road. Repeated resurfacing works to repair cracks in the road are evident.

- ▶ Reprofilng for 50 metres across the differential bump involving excavation and reconstruction of pavement foundation with a geogrid reinforced compliant road foundation;
- ▶ Future resurfacing interventions to repair small scale crack damage; and
- ▶ Assess dry-stone wall and make good as appropriate maintaining current form and appearance.

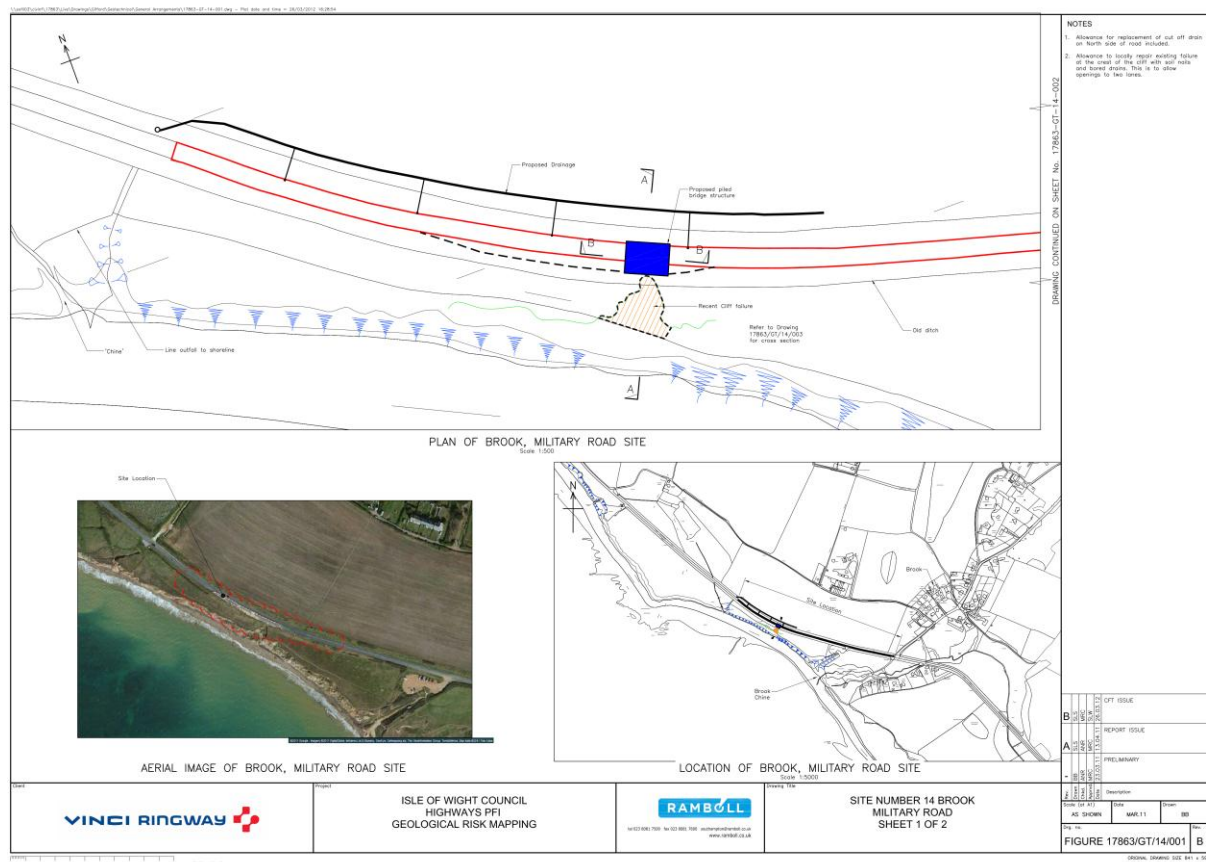
Figure 4.5: Site map of proposed engineering solution at Brook Chine, Military Road

- 4.5.1 Coastal landslip has regressed back close to the road leading to lane closure.

- ▶ 16 metre span pile-supported temporary steel bridge deck, pre-installed in path of regressing landslide; and
- ▶ Incorporation of effect of drainage recently installed by Isle of Wight.

- 4.5.2 Construction of a 16 metre clear span bridge deck carried on eight 750mm diameter piles. The construction will be a temporary modular steel bridge superstructure comprising multiple side-by-side units, consisting of rolled steel universal beam section longitudinal girders with rolled steel transverse beams and stringer beams. Construction depth will be approximately 850mm. The superstructure will be founded on simple beam abutments, carried on piles. The superstructure will be designed to be removable, and the sub-structure will be removed once exposed by coastal regression or development of the incised gulley feature (chine) in this area.
